# Main Gearbox Housing

**Name:** Main Gearbox Housing  
**Supplier:** Fansteel/Wellman Dynamics  
**AC Models Affected:** UH-60A  
**Part Number:** 70351-08111-002 \*FSP  
**Date of First Notification:** 11/09/2006  
**Escape Type/Category:** External / Cat TBD

# Fansteel Wellman Inspection Check Sheet

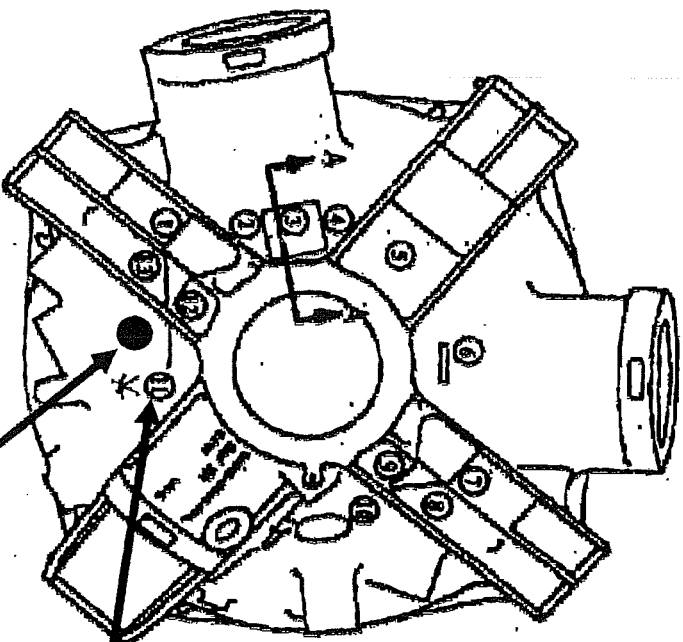
Part was checked and measures <.280 Min. Wall in this location.

Part was re-validated and actual wall thickness checks to these values at the specific location marked #11 only.
